Michigan Dairy Review

Treatment of Milk House Wash Water

Steven Safferman
Dept. of Biosystems and Agricultural Engineering
Lloyd Rozema
Aqua Treatment Technologies, Grimsby, Ontario, Canada

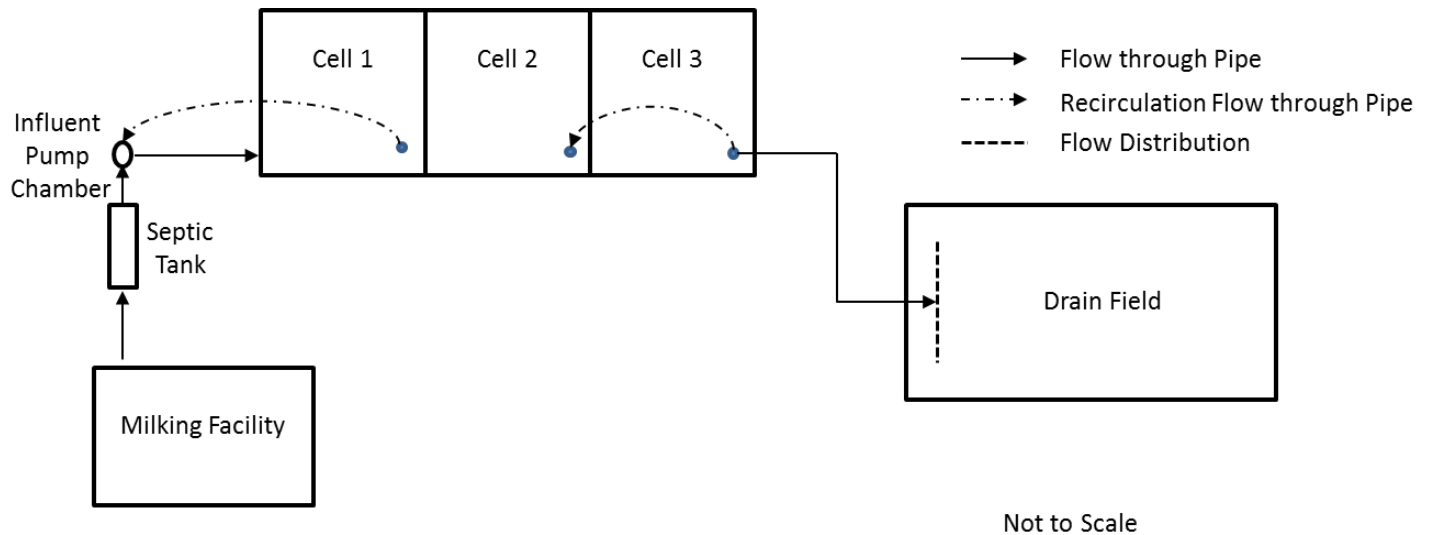
Figure 1: Schematic of the vertical flow constructed wetland.

Figure 1 shows a plan view of the VFW. Each cell is 16 ft wide by 16 ft long and 4 ft deep. The cells are lined with a water tight membrane (Figure 2). Pea gravel was used as the media because of its high porosity to minimize the potential for clogging. The initial vegetation consisted of Irish Virginica and Spartina Pectinata (cord grass), in approximately equal quantities. Vegetation helps keep the media open and provides oxygen in summer when it is needed the most because of the high rate of microbial degradation and the low solubility of oxygen in the water.

Milk house wastewater first enters a 500-gal septic site where solids settle and scum floats. The water then proceeds to the influent pump chamber where it is mixed with recycled effluent water from cell 1. Dosing into cell 1 is controlled by a level switch. During warm weather the water is dosed to the surface of each of the cells of the VFW (Figure 3). In colder seasons, flow is subsurface discharged, approximately 18 inches below the surface, so that freezing does not occur. Water percolates through the media to the bottom of the cell where it enters a drainage tile which allows it to flow to the cell's effluent sump (Figure 2). A pump moves the effluent back to the influent pump chamber and another pump, operated by a level switch, moves excess water to cell 2. This cell is designed to remove most of the carbon (as measured by chemical oxygen demand) and nitrify ammonia to nitrate. The second cell is kept saturated by the use of a riser in the effluent pipe before the water falls into the effluent sump. Water is not recycled.

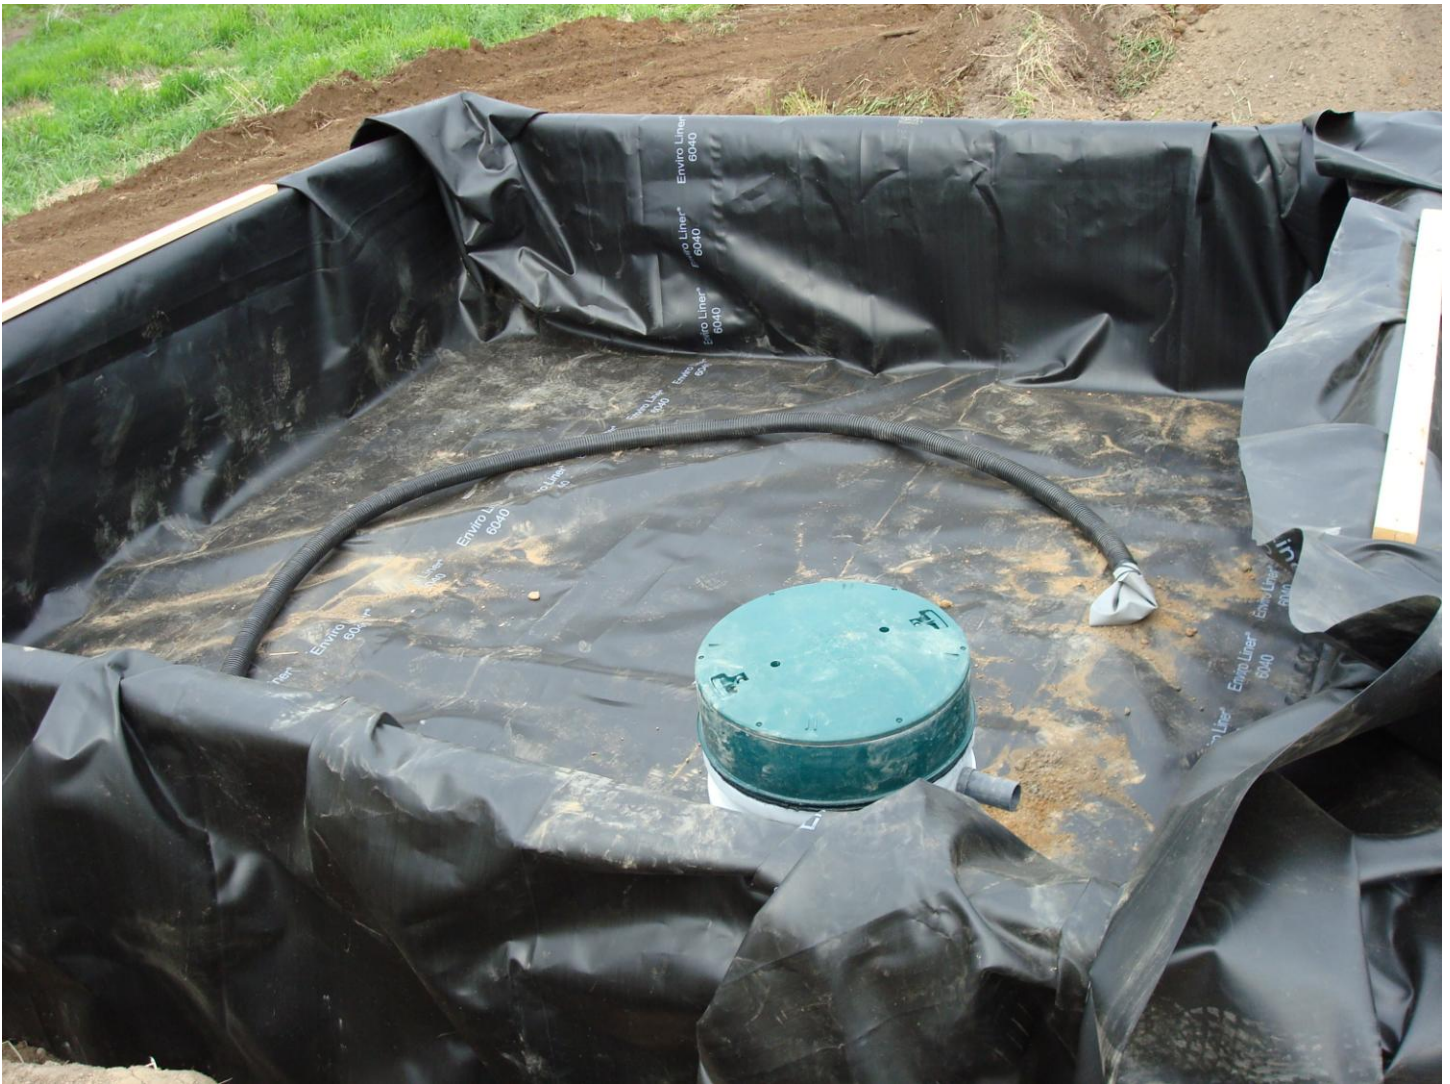
Figure 2: Empty VFW cell lined with drainage tile to collect percolated water.

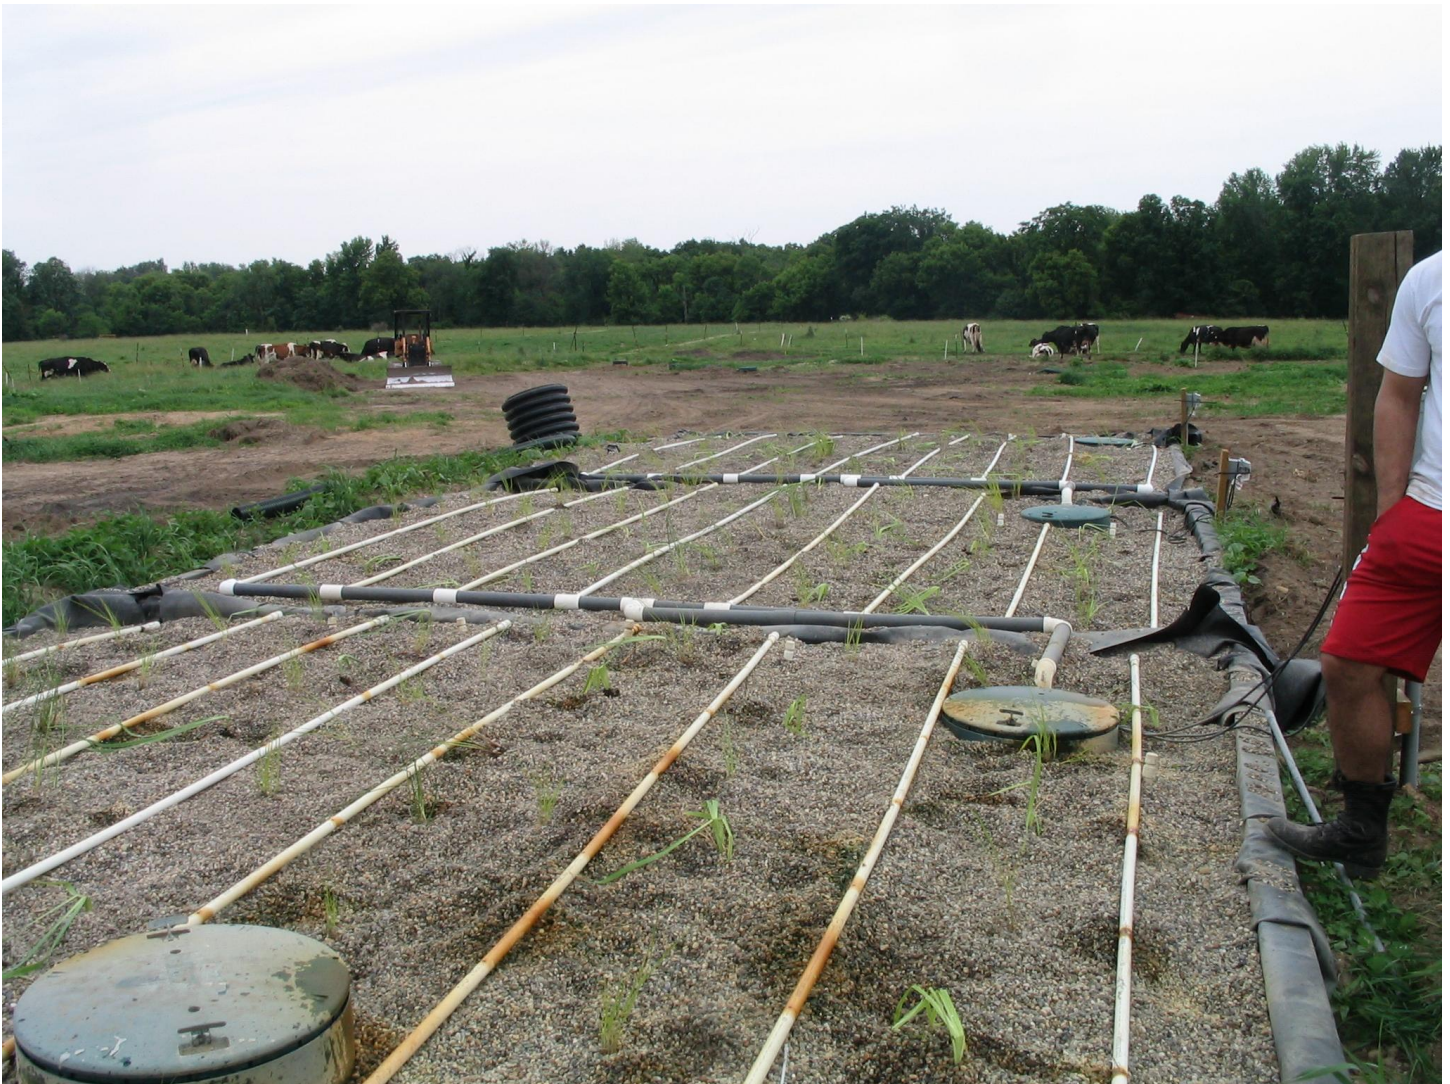
Figure 3: Surface distribution of water onto the recently vegetated VFW during warm weather season.

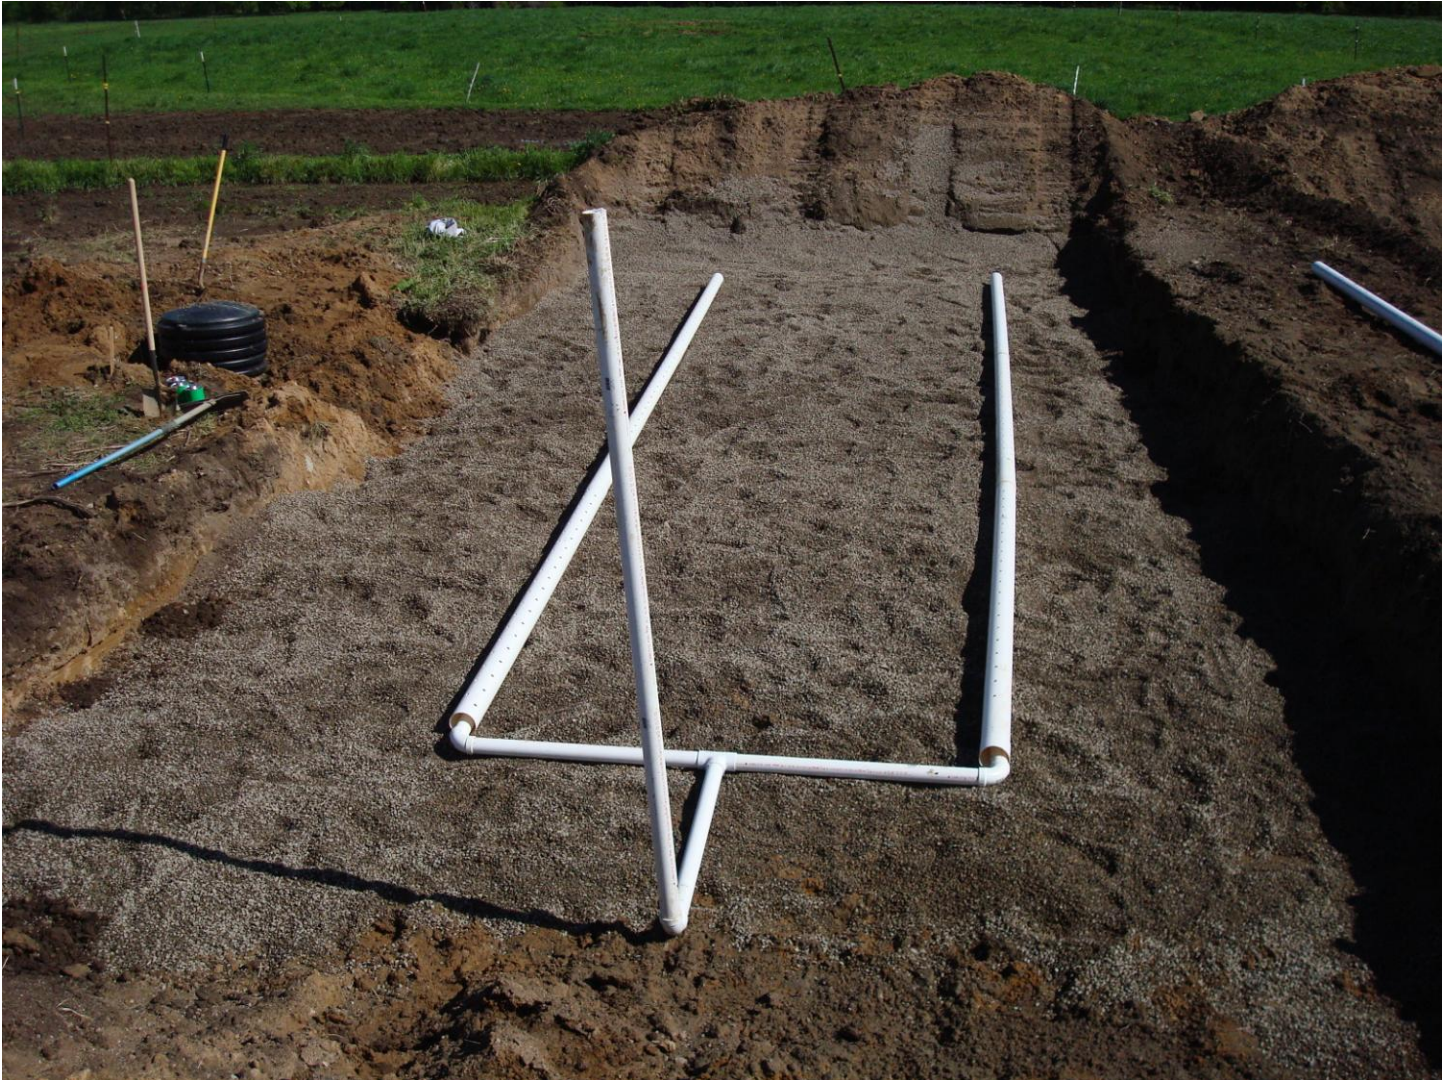
Figure 4: Drain field under construction.

As in cell 1, water is collected, transported through the riser into the effluent sump, and pumped to cell 3. This cell transforms the nitrate into nitrogen gas (denitrification). The third cell polishes the water, primarily removing excess carbon to very low levels. A pump in the effluent sump operates on a level switch to both recirculate part of the water back to the cell 2 effluent sump (which also serves as the influent sump for cell 3) and the balance to a drain field. The distribution is controlled by a valve on the recirculation line. All pumps are rated at 1 quarter horsepower. The drain field is 32 ft long and 16 ft wide with an approximately 2 ft bed of pea gravel.

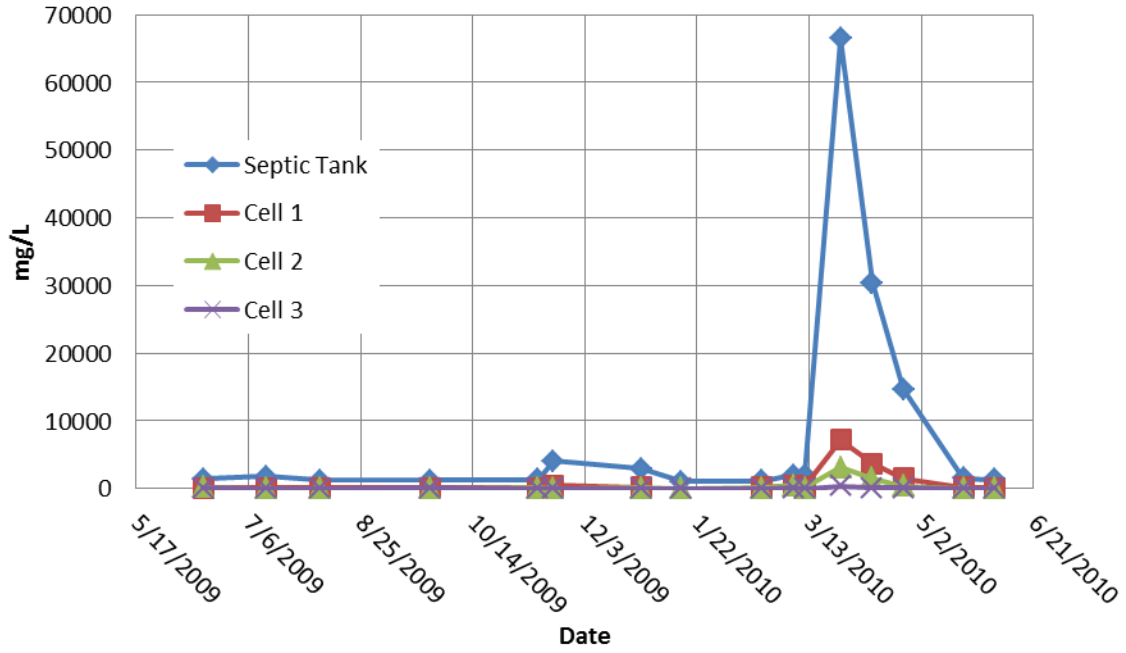
Figure 5: Chemical oxygen demand (mg/L) as related to calendar date.

Effluent COD levels were very low through the entire one year project period (Figure 5 on page 8). The “Septic Tank” designation is the water from the effluent end of that tank before dilution with cell 1 recirculation water. “Cell 1” and similar represent the effluent from that cell where “Cell 3” is the final VFW effluent before the drain field. The average VFW effluent concentration was 59 mg/L/gallon with a standard deviation of 87 mg/L. Most was removed in cell 1. These values were highly skewed by a surge in mid-March resulting from the need to dump a bulk tank of milk into the septic tank. The septic tank was ultimately pumped a few weeks later because of the accumulation of floating fats but, as shown, the VFW proved to be resilient as effluent levels did not rise significantly.
